**Flood Control Project Maintenance
Levee Inspections**

Maintenance Issue Types Only, Levee Inspection Report By Mile - Spring 2019

Reclamation District No. 2092 Dos Rios

Waterway	Bank	Unit Miles	Inspection Start/End	Inspector
Unit No. 01 San Joaquin River	Right	3.71	03/12/2019 03/12/2019	Corey Fujitani

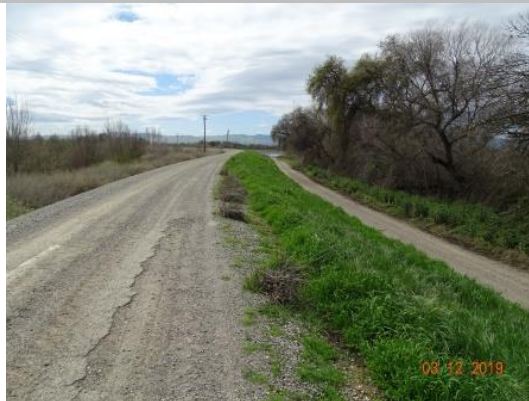
Photo 1 of 1 : SP_2019_RD2092_116_29_20190313_00059.jpg

LM Start	0.10	Rating **	M	Issue No.	29
LM End	1.56	Issue Type +	Ma	Location *	WS
Category	Earthen Levee			GPS Latitude/Longitude	
				Start	End
Item	Vegetation			37.602433 °	37.587612 °
				-121.159959 °	-121.162449 °
DWR ID	DWR_RD2092_01_s_2019_29				
Comment Code					
V1 : Control annual grass and weeds on the levee slopes and easements.					
Inspector Comment

Moderate grassy vegetation along waterside slope. (Spring 2019)

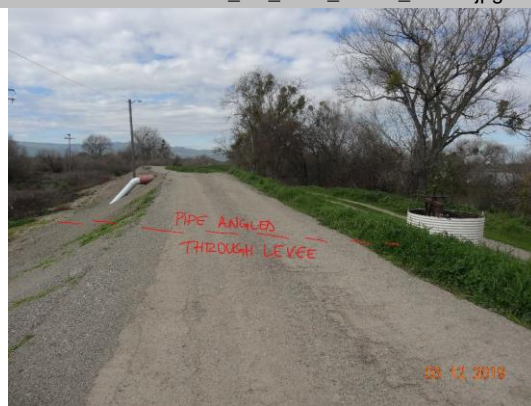
Photo 1 of 3 : UCIP_SP_2019_53799_79055.jpg

LM Start	0.18	Rating **	U	Issue No.	973	
LM End	0.18	Issue Type +	Ma	Location *		
Category	Supplemental			GPS Latitude/Longitude		
				Start	End	
Item	DWR UCIP LMA Responsibility			37.602031 °	37.602031 °	
				-121.161249 °	-121.161249 °	
DWR ID	20561

Comment Code						
Inspector Comment						
FS_ID:53799 DS_ID:20561 EP_NO: N/A Repair Type: Urgent Crossing Status: Found UCIP Comments: 03/12/2019 A thorough internal evaluation of this crossing is necessary. Pipe shows evidence of pipe integrity (LS) issues (pipe wall sections missing on LS inlet) and levee integrity issues (sink hole visible along LS pipe alignment). Internal inspection is recommended for this crossing to determine the extent of pipe damage through the levee. Pipe crosses the levee at an angle at a depth of about 19 feet. Recommend caution be taken at this crossing when driving over levee until additional information becomes available to determine condition of pipe through levee. Recommend cover be placed on riser to address safety concern (riser is 80 inches in diameter and about 19 feet deep). Slide gate appears to be blocked by sediment/debris preventing slide gate to work properly. Unable to confirm if the flap gate located on the WS is still broken (see photo from 2017). (O. Magana - DWR UCIP)09/24/2013 Pipe rusted through at headwall on LS toe. Good candidate for video inspection. (W. Wylie - DWR UCIP) FIELD_STRUCT_DESC: 60-inch corrugated metal drainage pipe through the levee, 19 feet below the crown. Flap gate on the waterside (WS) end. Slide gate in an 80-inch corrugated metal pipe (CMP) riser on the WS slope. Concrete U-shaped headwalls on both ends. [Additional Reference(s): DWR Levee Log, 2005. USACE San Joaquin O&M Manual 5, August 1961, (HLM 0.18)]. FS Date: 3/12/2019 12:05:00 PM

Overview of levee with approximate pipe alignment (pipe angled through levee).

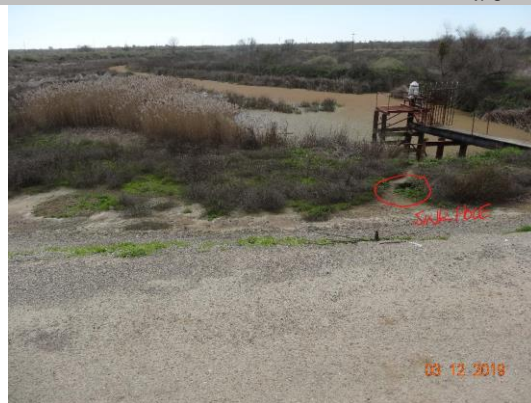
Photo 2 of 3 : UCIP_SP_2019_53799_79054.jpg

Comment Code						
Inspector Comment						
FS_ID:53799 DS_ID:20561 EP_NO: N/A Repair Type: Urgent Crossing Status: Found UCIP Comments: 03/12/2019 A thorough internal evaluation of this crossing is necessary. Pipe shows evidence of pipe integrity (LS) issues (pipe wall sections missing on LS inlet) and levee integrity issues (sink hole visible along LS pipe alignment). Internal inspection is recommended for this crossing to determine the extent of pipe damage through the levee. Pipe crosses the levee at an angle at a depth of about 19 feet. Recommend caution be taken at this crossing when driving over levee until additional information becomes available to determine condition of pipe through levee. Recommend cover be placed on riser to address safety concern (riser is 80 inches in diameter and about 19 feet deep). Slide gate appears to be blocked by sediment/debris preventing slide gate to work properly. Unable to confirm if the flap gate located on the WS is still broken (see photo from 2017). (O. Magana - DWR UCIP)09/24/2013 Pipe rusted through at headwall on LS toe. Good candidate for video inspection. (W. Wylie - DWR UCIP) FIELD_STRUCT_DESC: 60-inch corrugated metal drainage pipe through the levee, 19 feet below the crown. Flap gate on the waterside (WS) end. Slide gate in an 80-inch corrugated metal pipe (CMP) riser on the WS slope. Concrete U-shaped headwalls on both ends. [Additional Reference(s): DWR Levee Log, 2005. USACE San Joaquin O&M Manual 5, August 1961, (HLM 0.18)]. FS Date: 3/12/2019 12:05:00 PM

LS view: overview of LS with sink hole visible along pipe alignment.

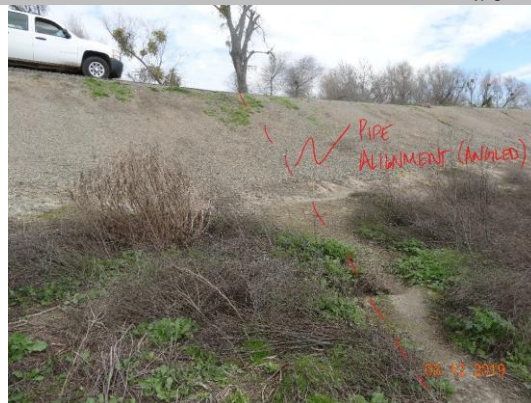
Photo 3 of 3 : UCIP_SP_2019_53799_79058.jpg

Comment Code						
Inspector Comment						
FS_ID:53799 DS_ID:20561 EP_NO: N/A Repair Type: Urgent Crossing Status: Found UCIP Comments: 03/12/2019 A thorough internal evaluation of this crossing is necessary. Pipe shows evidence of pipe integrity (LS) issues (pipe wall sections missing on LS inlet) and levee integrity issues (sink hole visible along LS pipe alignment). Internal inspection is recommended for this crossing to determine the extent of pipe damage through the levee. Pipe crosses the levee at an angle at a depth of about 19 feet. Recommend caution be taken at this crossing when driving over levee until additional information becomes available to determine condition of pipe through levee. Recommend cover be placed on riser to address safety concern (riser is 80 inches in diameter and about 19 feet deep). Slide gate appears to be blocked by sediment/debris preventing slide gate to work properly. Unable to confirm if the flap gate located on the WS is still broken (see photo from 2017). (O. Magana - DWR UCIP)09/24/2013 Pipe rusted through at headwall on LS toe. Good candidate for video inspection. (W. Wylie - DWR UCIP) FIELD_STRUCT_DESC: 60-inch corrugated metal drainage pipe through the levee, 19 feet below the crown. Flap gate on the waterside (WS) end. Slide gate in an 80-inch corrugated metal pipe (CMP) riser on the WS slope. Concrete U-shaped headwalls on both ends. [Additional Reference(s): DWR Levee Log, 2005. USACE San Joaquin O&M Manual 5, August 1961, (HLM 0.18)]. FS Date: 3/12/2019 12:05:00 PM

LS view: pipe crosses levee at angle, approximate alignment on LS.

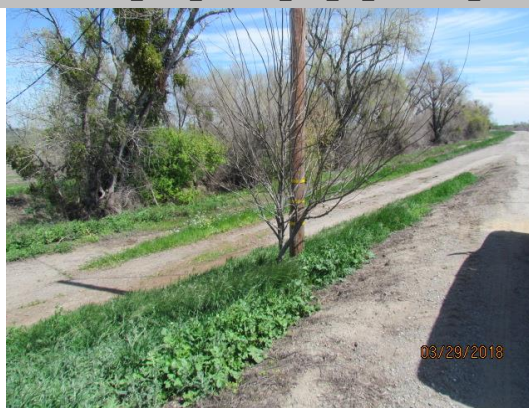
Photo 1 of 1 : SP_2019_RD2092_116_31_20190307_00014.jpg

LM Start	0.44	Rating **	M	Issue No.	31
LM End	0.44	Issue Type +	Ma	Location *	WS
Category	Earthen Levee			GPS Latitude/Longitude	
				Start	End
Item	Trim / Thin Trees			37.601149 °	37.601149 °
				-121.165772 °	-121.165772 °
DWR ID	DWR_RD2092_01_s_2018_31				
Comment Code					
T2 : Thin trees to allow visibility of the ground and room to flood fight.					
Inspector Comment					
Remove small tree on waterward shoulder before tree is establish.

Looking upstream at small tree on waterward should next to pole. (Spring 2018)

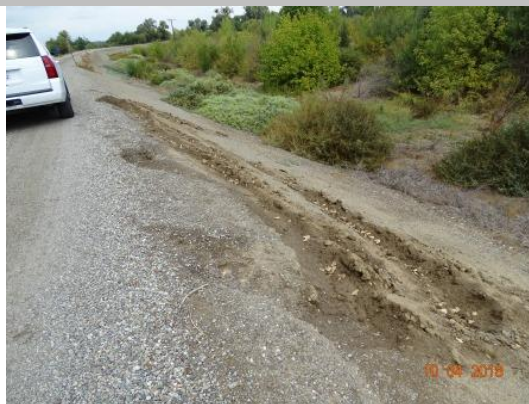
Photo 1 of 1 : SP_2019_RD2092_116_40_20190307_00024.jpg

LM Start	0.59	Rating **	M	Issue No.	40
LM End	0.59	Issue Type +	Ma	Location *	LS
Category	Earthen Levee			GPS Latitude/Longitude	
				Start	End
Item	Slope Stability			37.599406 °	37.599406 °
				-121.167083 °	-121.167083 °
DWR ID	DWR_RD2092_01_f_2018_40				
Comment Code					
S3 : Repair the levee slope damaged by vehicle traffic and prevent access where possible.					
Inspector Comment					
Vehicle tracks in landside slope should be repaired.

Vehicle tracks on landside slope approximately 6" deep perpendicular to the slope. (Fall 2018)

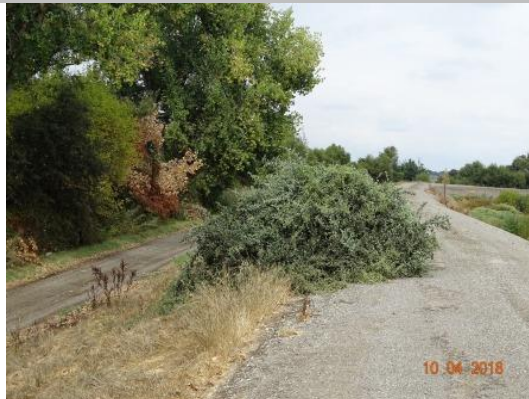
Photo 1 of 1 : SP_2019_RD2092_116_38_20190307_00022.jpg

Brush on waterside shoulder should be cleared. (Fall 2018)

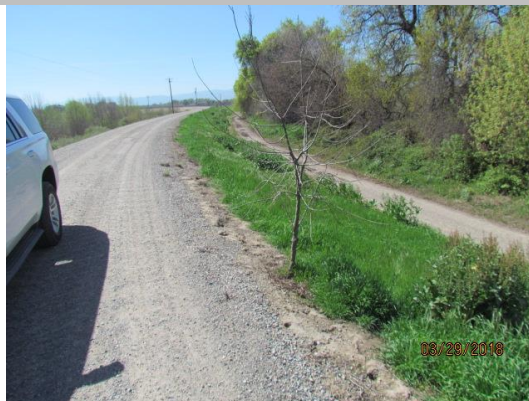
Photo 1 of 1 : SP_2019_RD2092_116_21_20190307_00011.jpg

LM Start	0.61	Rating **	M	Issue No.	21
LM End	0.61	Issue Type +	Ma	Location *	WS
Category	Earthen Levee			GPS Latitude/Longitude	
				Start	End
Item	Trim / Thin Trees			37.599208 °	37.599208 °
				-121.167150 °	-121.167150 °
DWR ID	DWR_RD2092_01_s_2018_21				
Comment Code					
T2 : Thin trees to allow visibility of the ground and room to flood fight.					
Inspector Comment					
Remove small tree on waterward shoulder before tree is established.

Looking downstream at small tree on waterward slope. (Spring 2018)

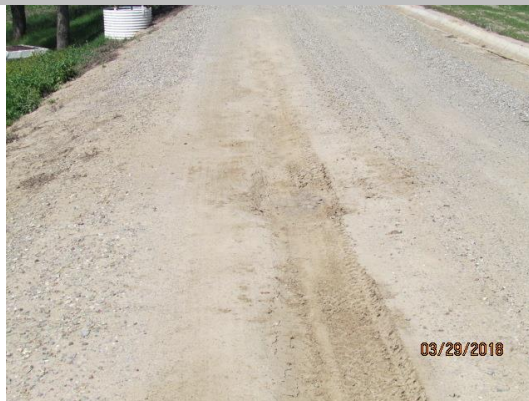
Photo 1 of 1 : SP_2019_RD2092_116_39_20190307_00023.jpg

Looking upstream at rutting and depression on levee crown. (Spring 2018)

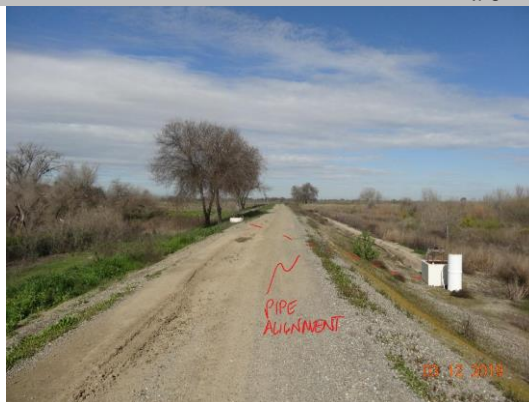
Photo 1 of 3 : UCIP_SP_2019_53820_79073.jpg

LM Start	1.30	Rating **	M	Issue No.	977	
LM End	1.30	Issue Type +	Ma	Location *		
Category	Supplemental			GPS Latitude/Longitude		
				Start	End	
Item	DWR UCIP LMA Responsibility			37.590603 °	37.590603 °	
				-121.164111 °	-121.164111 °	
DWR ID	20562

Comment Code						
Inspector Comment						
FS_ID:53820 DS_ID:20562 EP_NO: N/A Repair Type: Non-Urgent Crossing Status: Found UCIP Comments: 03/12/2019 During UCIP visual inspection, no pipe or levee integrity issues were observed. Distribution box located on the WS is falling apart (bricks missing). This crossing is an active crossing however, no permit has been found authorizing crossing. Need to determine who maintains and operates this crossing. (O. Magana - DWR UCIP) FIELD_STRUCT_DESC: 36-inch corrugated metal drainage pipe through the levee, 15 feet below the crown. Slide gate in a 48-inch corrugated metal pipe (CMP) riser on the waterside (WS) slope. 4-foot by 6-foot concrete distribution box on the landside (LS) toe. 5-foot by 5-foot concrete riser on the WS toe. [Additional Reference(s): DWR Levee Log, 2005. USACE San Joaquin O&M Manual 5, August 1961, (HLM 1.31)]. FS Date: 3/12/2019 12:06:00 PM

Overview of pipe alignment through levee, photo taking looking d/s toward crossing.

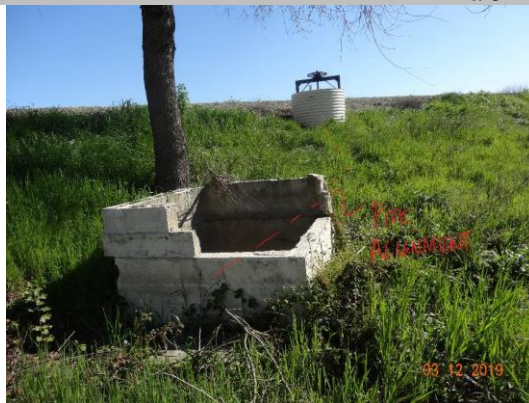
Photo 2 of 3 : UCIP_SP_2019_53820_79078.jpg

Comment Code						
Inspector Comment						
FS_ID:53820 DS_ID:20562 EP_NO: N/A Repair Type: Non-Urgent Crossing Status: Found UCIP Comments: 03/12/2019 During UCIP visual inspection, no pipe or levee integrity issues were observed. Distribution box located on the WS is falling apart (bricks missing). This crossing is an active crossing however, no permit has been found authorizing crossing. Need to determine who maintains and operates this crossing. (O. Magana - DWR UCIP) FIELD_STRUCT_DESC: 36-inch corrugated metal drainage pipe through the levee, 15 feet below the crown. Slide gate in a 48-inch corrugated metal pipe (CMP) riser on the waterside (WS) slope. 4-foot by 6-foot concrete distribution box on the landside (LS) toe. 5-foot by 5-foot concrete riser on the WS toe. [Additional Reference(s): DWR Levee Log, 2005. USACE San Joaquin O&M Manual 5, August 1961, (HLM 1.31)]. FS Date: 3/12/2019 12:06:00 PM

WS view: approximate alignment on WS.

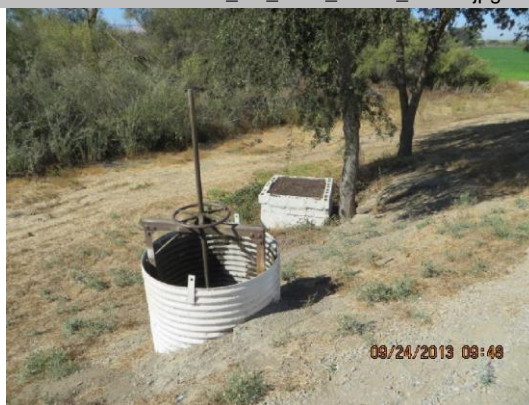
Photo 3 of 3 : UCIP_SP_2019_53820_35213.jpg

Slide gate in 48-inch CMP riser on WS slope.

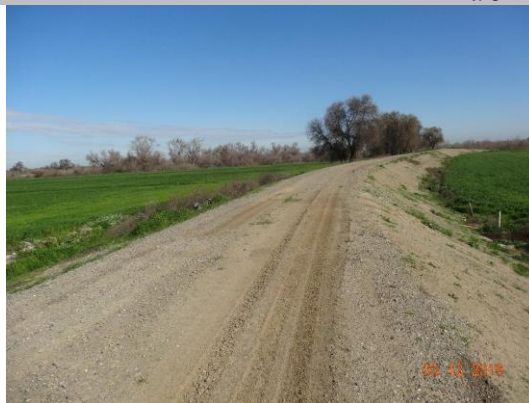
Photo 1 of 3 : UCIP_SP_2019_53817_79086.jpg

Comment Code					
Inspector Comment					
FS_ID:53817 DS_ID:20563 EP_NO: N/A Repair Type: Urgent Crossing Status: Found UCIP Comments: 03/12/2019 A thorough internal evaluation of this crossing is required, pipe shows evidence of pipe integrity (LS) issues (pipe wall sections missing on WS outlet). Internal inspection is recommended for this crossing to determine the extent of pipe damage through the levee. Maintenance issues identified at this crossing include: flap gate missing on WS, debris found inside concrete distribution box, and missing cover on riser. No permit has been identified for this crossing. Need to determine who maintains crossing; crossing appears functional. (O. Magana - DWR UCIP) FIELD_STRUCT_DESC: 24-inch corrugated metal drainage pipe through the levee, 14 feet below the crown. Slide gate in a corrugated metal pipe (CMP) riser on the waterside (WS) slope. Concrete U-shaped headwall at the landside (LS) toe. [Additional Reference(s): DWR Levee Log, 2005. USACE San Joaquin O&M Manual 5, August 1961, (HLM 1.71)]. FS Date: 3/12/2019 12:07:00 PM

Overview of levee crown looking d/s towards pipe crossing.

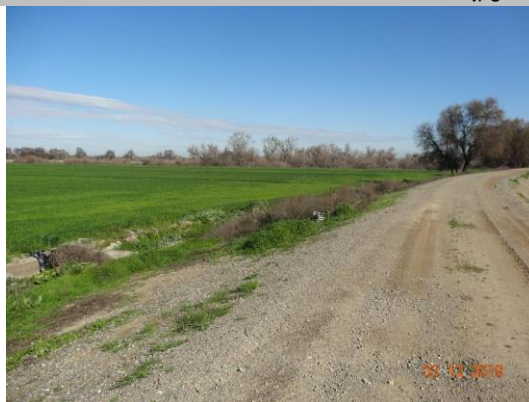
Photo 2 of 3 : UCIP_SP_2019_53817_79087.jpg

WS view: overview of WS.

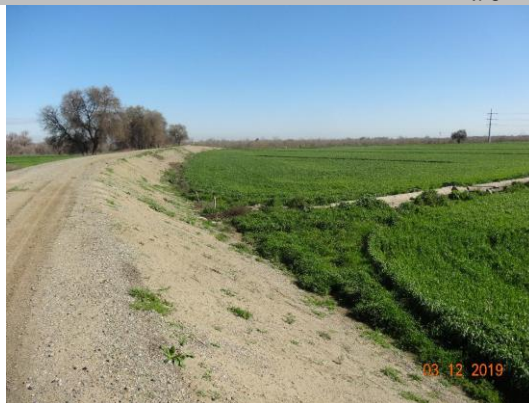
Photo 3 of 3 : UCIP_SP_2019_53817_79085.jpg

Comment Code						
Inspector Comment						
FS_ID:53817 DS_ID:20563 EP_NO: N/A Repair Type: Urgent Crossing Status: Found UCIP Comments: 03/12/2019 A thorough internal evaluation of this crossing is required, pipe shows evidence of pipe integrity (LS) issues (pipe wall sections missing on WS outlet). Internal inspection is recommended for this crossing to determine the extent of pipe damage through the levee. Maintenance issues identified at this crossing include: flap gate missing on WS, debris found inside concrete distribution box, and missing cover on riser. No permit has been identified for this crossing. Need to determine who maintains crossing; crossing appears functional. (O. Magana - DWR UCIP) FIELD_STRUCT_DESC: 24-inch corrugated metal drainage pipe through the levee, 14 feet below the crown. Slide gate in a corrugated metal pipe (CMP) riser on the waterside (WS) slope. Concrete U-shaped headwall at the landside (LS) toe. [Additional Reference(s): DWR Levee Log, 2005. USACE San Joaquin O&M Manual 5, August 1961, (HLM 1.71)]. FS Date: 3/12/2019 12:07:00 PM

LS view: overview of LS.

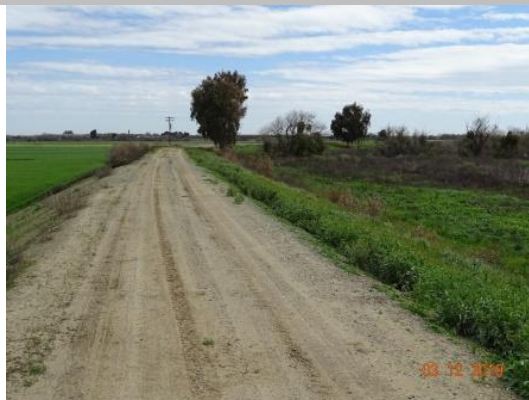
Photo 1 of 2 : SP_2019_RD2092_116_32_20190313_00060.jpg

LM Start	1.86	Rating **	M	Issue No.	32
LM End	2.71	Issue Type +	Ma	Location *	WS
Category	Earthen Levee			GPS Latitude/Longitude	
				Start	End
Item	Vegetation			37.584005 °	37.576007 °
				-121.162040 °	-121.157221 °
DWR ID	DWR_RD2092_01_f_2018_32				
Comment Code					
V1 : Control annual grass and weeds on the levee slopes and easements.					
Inspector Comment

Control grassy vegetation along waterside slope. (Spring 2019)

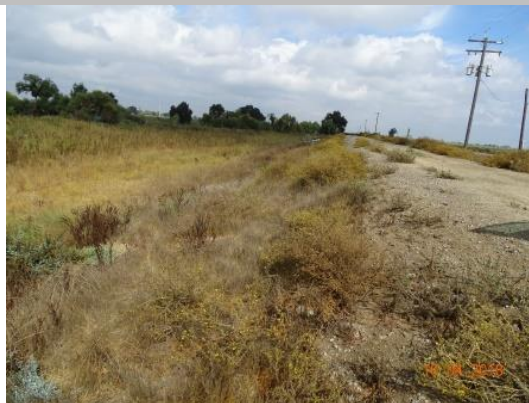
Photo 2 of 2 : SP_2019_RD2092_116_32_20190307_00015.jpg

Vegetation on waterside slope should be maintained. (Fall 2018)

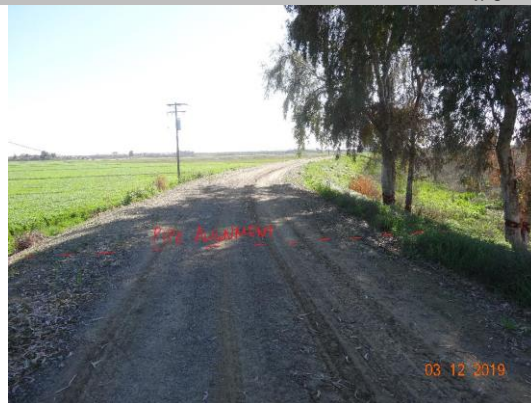
Photo 1 of 3 : UCIP_SP_2019_53814_79091.jpg

Comment Code						
Inspector Comment						
FS_ID:53814 DS_ID:20564 EP_NO: N/A Repair Type: Non-Urgent Crossing Status: Found UCIP Comments: 03/12/2019 Concrete headwall found on LS toe. Pipe appears to have been grouted through. No other appurtenances were found during inspection. WS outlet was not found. Need to coordinate with the CVFPB to determine if additional steps are needed to comply with Title 23. (O. Magana - DWR UCIP) FIELD_STRUCT_DESC: *ABANDONED* 30-inch corrugated metal drainage pipe through the levee, 15 feet below the crown. Flap gate on the waterside (WS) end. Concrete U-shaped headwalls on both ends. Filled with concrete on the landside (LS) toe. [Additional Reference(s): DWR Levee Log, 2005. USACE San Joaquin O&M Manual 5, August 1961, (HLM 2.10), 36-inch pipe listed]. FS Date: 3/12/2019 12:08:00 PM

Overview of levee crown, looking u/s from d/s, and approximate pipe alignment.

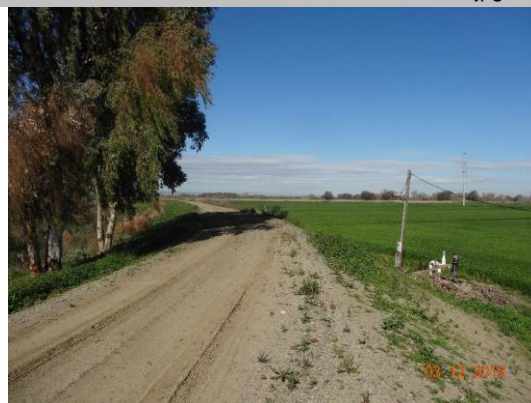
Photo 2 of 3 : UCIP_SP_2019_53814_79092.jpg

Overview of levee at crossing, photo taken u/s looking d/s towards pipe crossing.

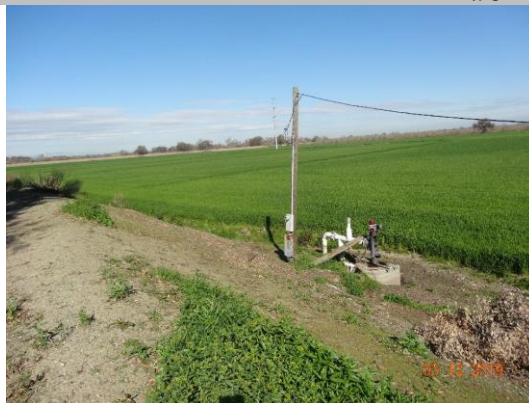
Photo 3 of 3 : UCIP_SP_2019_53814_79093.jpg

Comment Code						
Inspector Comment						
FS_ID:53814 DS_ID:20564 EP_NO: N/A Repair Type: Non-Urgent Crossing Status: Found UCIP Comments: 03/12/2019 Concrete headwall found on LS toe. Pipe appears to have been grouted through. No other appurtenances were found during inspection. WS outlet was not found. Need to coordinate with the CVFPB to determine if additional steps are needed to comply with Title 23. (O. Magana - DWR UCIP) FIELD_STRUCT_DESC: *ABANDONED* 30-inch corrugated metal drainage pipe through the levee, 15 feet below the crown. Flap gate on the waterside (WS) end. Concrete U-shaped headwalls on both ends. Filled with concrete on the landside (LS) toe. [Additional Reference(s): DWR Levee Log, 2005. USACE San Joaquin O&M Manual 5, August 1961, (HLM 2.10), 36-inch pipe listed]. FS Date: 3/12/2019 12:08:00 PM

LS view: concrete riser, power pole, and groundwater pump station.

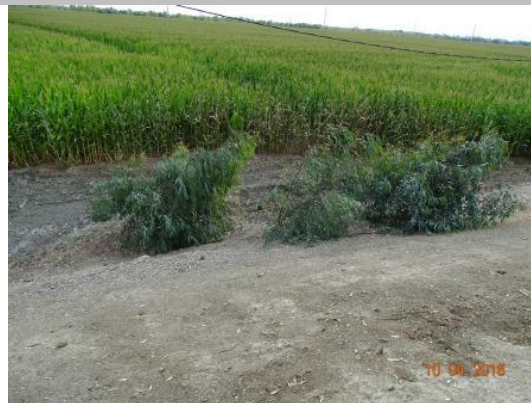
Photo 2 of 2 : SP_2019_RD2092_116_43_20190307_00025.jpg

View of saplings along landside levee toe. (Fall 2018)

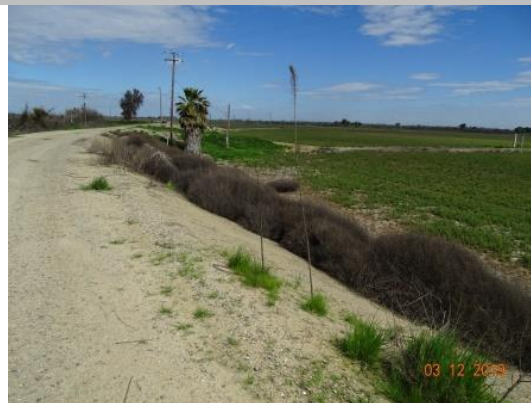
Photo 1 of 2 : SP_2019_RD2092_116_25_20190313_00062.jpg

View of vegetation along landside slope looking downstream. (Spring 2019)

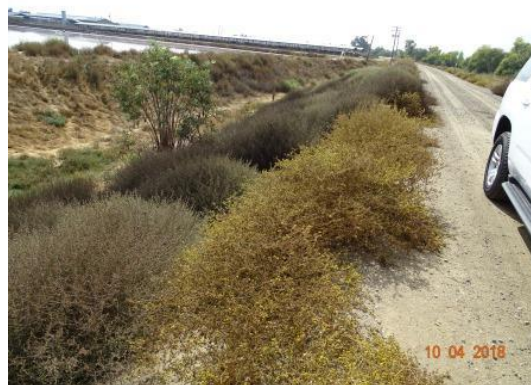
Photo 2 of 2 : SP_2019_RD2092_116_25_20190307_00012.jpg

View of vegetation along landside slope looking upstream. (Fall 2018)

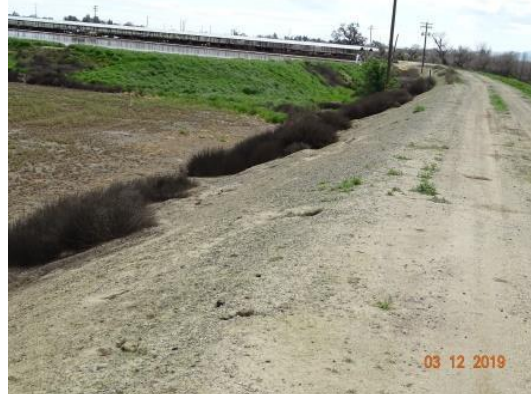
Photo 1 of 1 : SP_2019_RD2092_116_41_20190313_00063.jpg

LM Start	2.53	Rating **	M	Issue No.	41
LM End	2.69	Issue Type +	Ma	Location *	LS
Category	Earthen Levee			GPS Latitude/Longitude	
				Start	End
Item	Vegetation			37.578657 °	37.576327 °
				-121.156997 °	-121.157231 °
DWR ID	DWR_RD2092_01_s_2019_41				
Comment Code					
V1 : Control annual grass and weeds on the levee slopes and easements.					
Inspector Comment

View of brush along landside slope looking upstream. (Spring 2019)

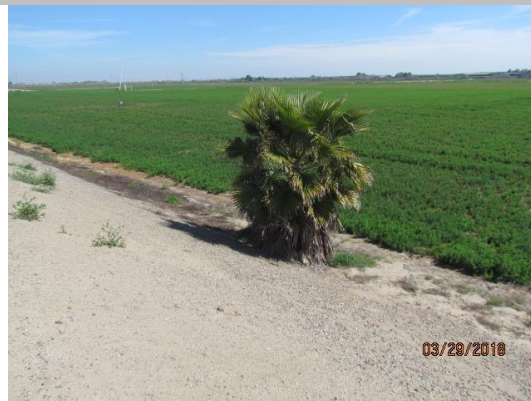
Photo 1 of 1 : SP_2019_RD2092_116_19_20190307_00009.jpg

LM Start	2.55	Rating **	U	Issue No.	19
LM End	2.55	Issue Type +	Ma	Location *	LS
Category	Earthen Levee			GPS Latitude/Longitude	
				Start	End
Item	Vegetation			37.578333 °	37.578333 °
				-121.157011 °	-121.157011 °
DWR ID	DWR_RD2092_01_s_2018_19				
Comment Code					
V7 : Trees / Woody Vegetation					
Inspector Comment					
Palm tree at landward toe should be removed.

Looking at Palm tree at landward toe. (Spring 2018)

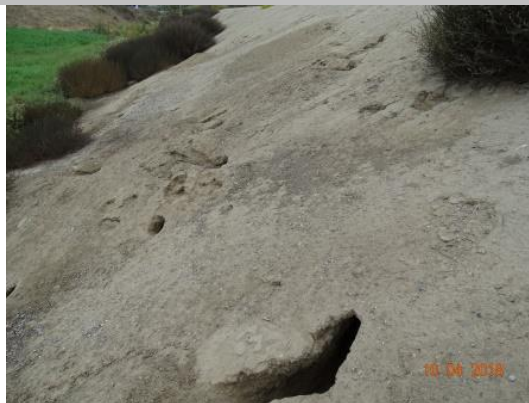
Photo 1 of 1 : SP_2019_RD2092_116_44_20190307_00026.jpg

View of animal burrows looking upstream. (Fall 2018)

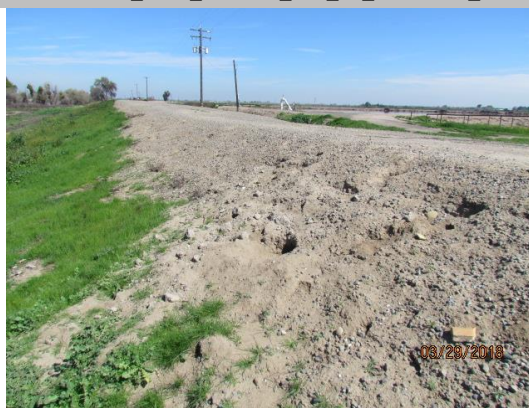
Photo 1 of 4 : SP_2019_RD2092_116_17_20190307_00005.jpg

LM Start	2.63	Rating **	U	Issue No.	17
LM End	2.76	Issue Type +	Ma	Location *	WS
Category	Earthen Levee			GPS Latitude/Longitude	
				Start	End
Item	Animal Control			37.577186 °	37.575364 °
				-121.157159 °	-121.157093 °
DWR ID	DWR_RD2092_01_s_2018_17				
Comment Code					
A1 : Exterminate rodents and backfill and compact or grout burrows.					
Inspector Comment					
Several large rodent holes within this reach need to be backfilled.

Looking upstream on waterward slope at several large rodent holes. (Spring 2018)

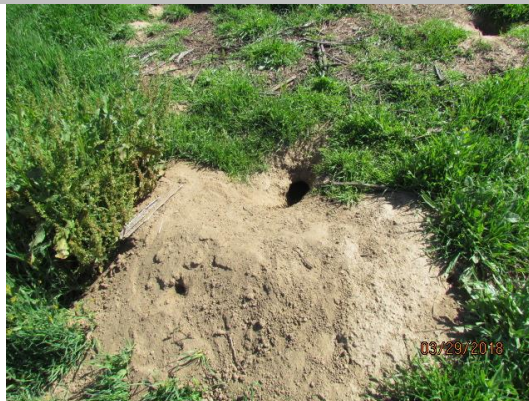
Photo 2 of 4 : SP_2019_RD2092_116_17_20190307_00006.jpg

Looking at typical large rodent holes on waterward slope. (Spring 2018)

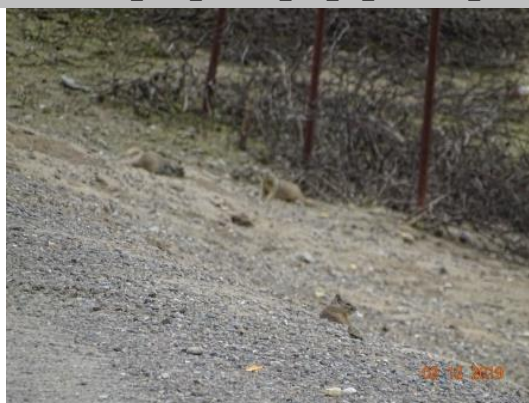
Photo 1 of 3 : SP_2019_RD2092_116_35_20190313_00064.jpg

LM Start	2.82	Rating **	U	Issue No.	35
LM End	3.01	Issue Type +	Ma	Location *	WS
Category	Earthen Levee			GPS Latitude/Longitude	
				Start	End
Item	Animal Control			37.574869 °	37.574141 °
				-121.156247 °	-121.152762 °
DWR ID	DWR_RD2092_01_s_2017_35				
Comment Code					
A1 : Exterminate rodents and backfill and compact or grout burrows.					
Inspector Comment

Squirrels observed along waterside slope. (Spring 2019)

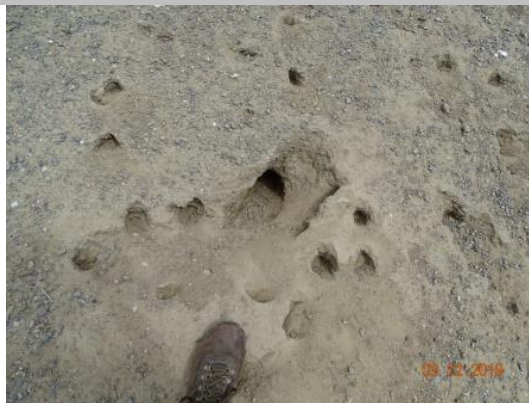
Photo 2 of 3 : SP_2019_RD2092_116_35_20190313_00065.jpg

View of typical rodent holes. (Spring 2019)

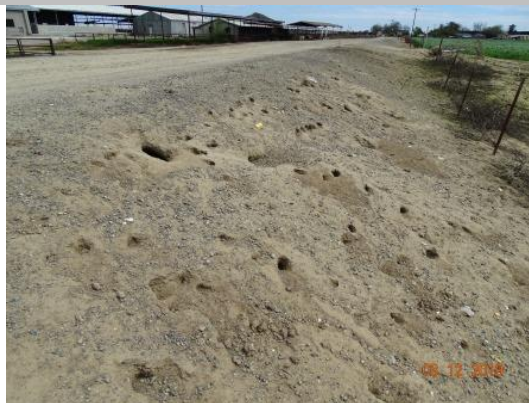
Photo 3 of 3 : SP_2019_RD2092_116_35_20190313_00066.jpg

View of several rodent burrows along waterside slope. (Spring 2019)

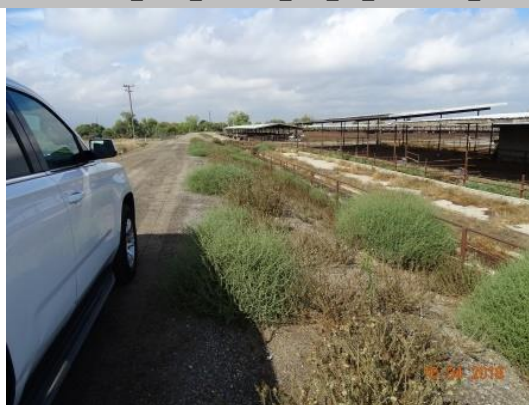
Photo 1 of 1 : SP_2019_RD2092_116_16_20190307_00004.jpg

Vegetation along landside slope. (Fall 2018)

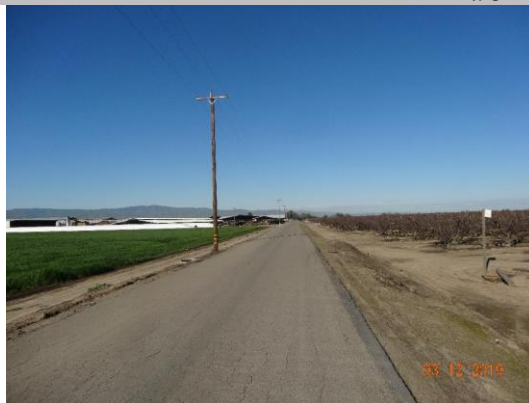
Photo 1 of 3 : UCIP_SP_2019_53786_79145.jpg

Comment Code						
Inspector Comment						
FS_ID:53786 DS_ID:20572 EP_NO: N/A Repair Type: Non-Urgent Crossing Status: Found UCIP Comments: 03/12/2019 No permit was found authorizing crossing. Unable to confirm if crossing is in use. Recommend adding cover to riser to address safety concern. No slide gate was found in CMP riser. If crossing is no longer in use, recommend proper abandonment or removal from levee. Owner will need to coordinate with CVFPB to be compliant with Title 23. (O. Magana - DWR UCIP) 09/24/2013 This pipe appears abandoned and if so, should be done so properly. (W. Wylie - DWR UCIP) FIELD_STRUCT_DESC: *ABANDONED* 36-inch corrugated metal drainage pipe through the levee, 11 feet below the crown. Slide gate in a corrugated metal pipe (CMP) riser on the waterside (WS) slope. Concrete headwalls on both ends. [Additional Reference(s): DWR Levee Log, 2005. USACE San Joaquin O&M Manual 5, August 1961, (HLM 3.52)]. FS Date: 3/12/2019 12:11:53 PM

Overview of levee crown looking d/s towards crossing.

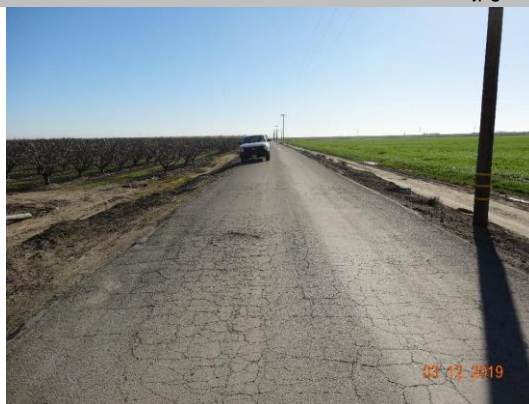
Photo 2 of 3 : UCIP_SP_2019_53786_79150.jpg

Overview of levee crown looking u/S towards crossing.

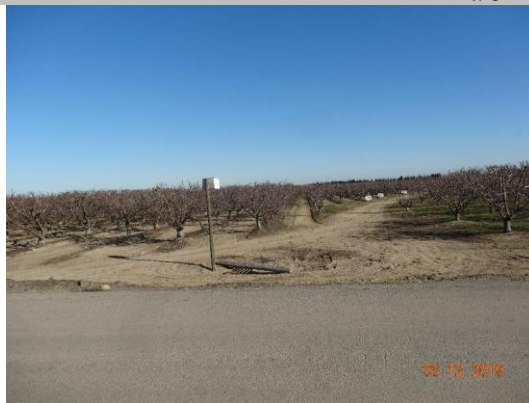
Photo 3 of 3 : UCIP_SP_2019_53786_79144.jpg

Comment Code						
Inspector Comment						
FS_ID:53786 DS_ID:20572 EP_NO: N/A Repair Type: Non-Urgent Crossing Status: Found UCIP Comments: 03/12/2019 No permit was found authorizing crossing. Unable to confirm if crossing is in use. Recommend adding cover to riser to address safety concern. No slide gate was found in CMP riser. If crossing is no longer in use, recommend proper abandonment or removal from levee. Owner will need to coordinate with CVFPB to be compliant with Title 23. (O. Magana - DWR UCIP) 09/24/2013 This pipe appears abandoned and if so, should be done so properly. (W. Wylie - DWR UCIP) FIELD_STRUCT_DESC: *ABANDONED* 36-inch corrugated metal drainage pipe through the levee, 11 feet below the crown. Slide gate in a corrugated metal pipe (CMP) riser on the waterside (WS) slope. Concrete headwalls on both ends. [Additional Reference(s): DWR Levee Log, 2005. USACE San Joaquin O&M Manual 5, August 1961, (HLM 3.52)]. FS Date: 3/12/2019 12:11:53 PM

LS view: overview of land use on LS.
